VILLAGE OF RUIDOSO WATER SYSTEM

# SOURCE WATER PROTECTION PLAN

March 27, 2014

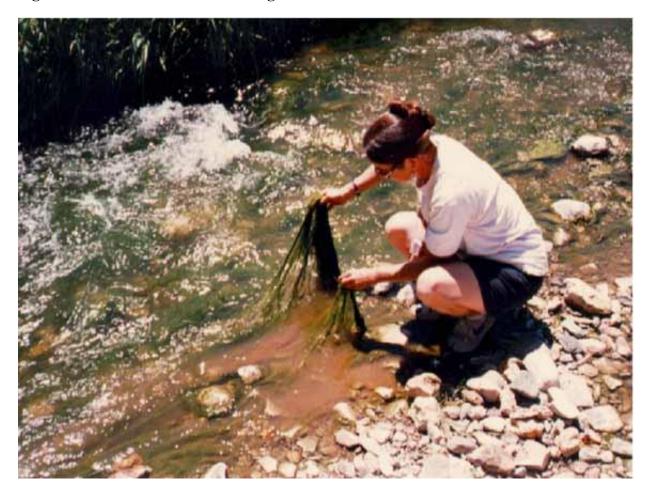
Figure 4. Historical Filamentous Algae Growth in the Rio Ruidoso.

Potential sources of impairment included municipal and domestic wastewater treatment systems, rangeland grazing, site clearance, stream bank modification/destabilization, and loss of riparian habitat. Nutrient imbalances have caused excessive growth of filamentous algae in the Rio Ruidoso in the past (Figure 4). These surveys were used to establish Total Maximum Daily Loads (TMDLs) for the affected streams (NMED, 2006).

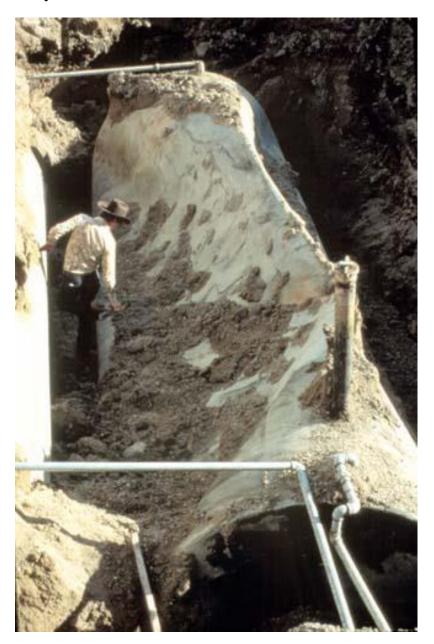
Figure 6. Leaky Underground Storage Tank that Contaminated the Original Ruidoso Hollywood Well with Diesel Fuel in 1985.

The original Hollywood well began pumping a mixture of groundwater and diesel fuel into the Ruidoso water distribution system on July 29, 1985, creating an emergency situation. Subsequent investigation determined that the source of contamination was a leaking underground diesel storage tank (Figure 6) located approximately 125 feet away from the Hollywood well. In 1987, a replacement well was drilled that is now also called the Hollywood well. NMED and the owner of the leaky storage tank signed a Settlement Agreement that provided for comprehensive investigation and cleanup of the spill. The site remains in a program of monitored natural attenuation.

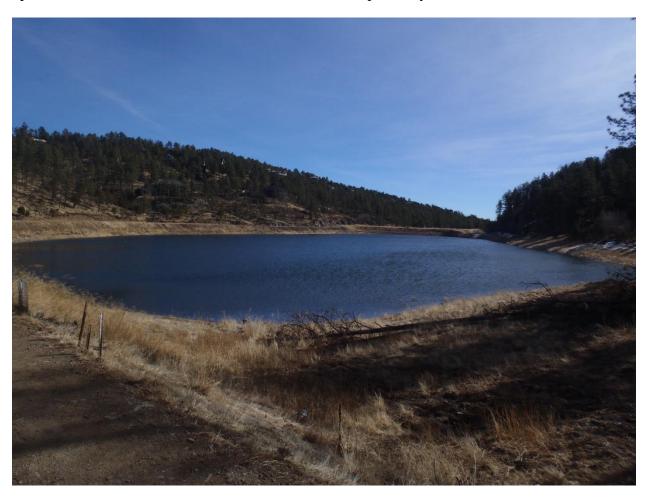
Alto Reservoir is located on Eagle Creek just west of Highway 48 in Alto. The Eagle Creek watershed was heavily damaged by the Little Bear Wildfire. Runoff from the burn scar has caused the use of Alto Reservoir as a source of drinking water for the Village of Ruidoso to be temporarily suspended. The Village intends to resume use of Alto Reservoir as a source of drinking water later this year. A number of manmade potential sources of contamination are located in the watershed including underground storage tanks for petroleum products and homes and cabins that utilize onsite wastewater systems. A segment of Eagle Creek about 2.7 miles upstream from Alto Reservoir has been identified as impaired by low flow alteration.

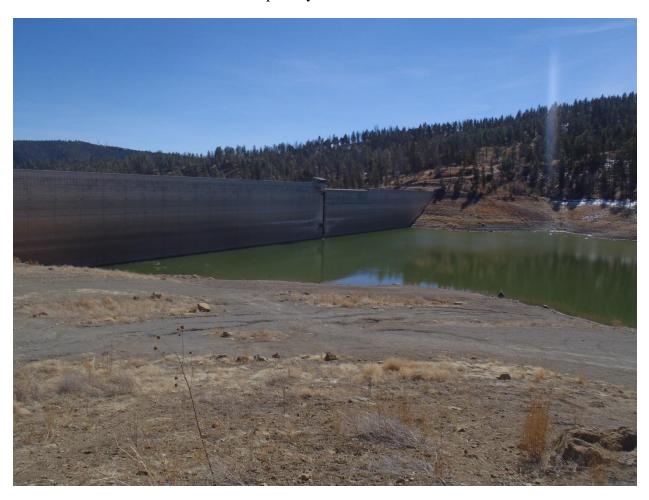
Grindstone Reservoir has a very small watershed located entirely within the Two Rivers Source Water Protection Area, and can receive water piped in from the Two Rivers and Upper Canyon Diversions. On the day this picture was taken, February 12, 2014, the water level in the reservoir was 51 feet below the elevation of the spillway.

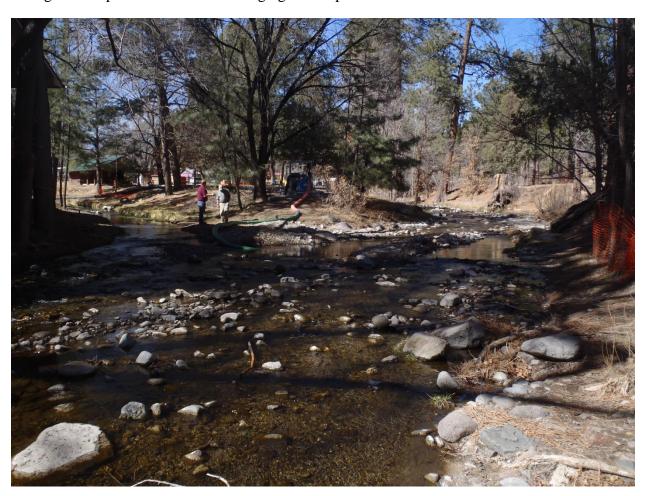
**Two Rivers Diversion, looking upstream.** Carrizo Creek is on the left, the Rio Ruidoso is on the right. Pump and hose are on the high ground upstream from the confluence.

The Two Rivers Diversion is located at the confluence of Carrizo Creek with the Rio Ruidoso and was given emergency authorization by the Office of the State Engineer. The Village of Ruidoso can divert water from this location up to Grindstone Reservoir when flow at the Hollywood gaging station reaches levels prescribed by the Office of the State Engineer. Both watercourses flow through developed areas with numerous potential sources of contamination. At the diversion location, Carrizo Creek is impaired with fecal coliform bacteria, and the Rio Ruidoso is impaired with temperature and turbidity. A number of homes and vacation cabins in the watersheds of these streams may utilize on site wastewater systems.

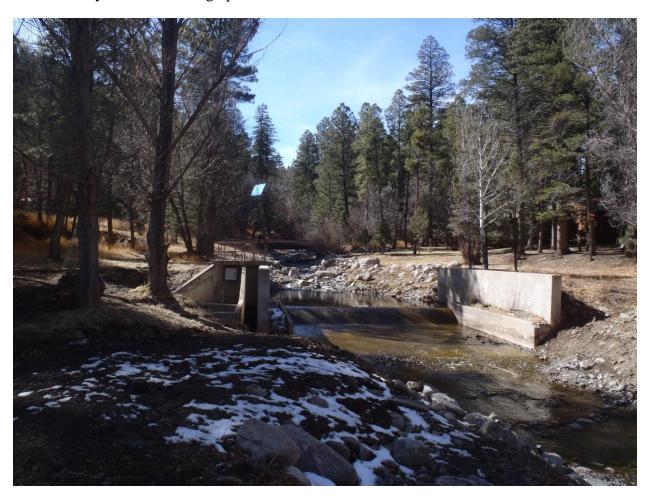
The Upper Canyon Diversion is located on the Rio Ruidoso and water can be transferred to Grindstone Reservoir. The Rio Ruidoso at this location is impaired by temperature and turbidity. Additionally, a number of homes and vacation cabins in this area may still utilize on site wastewater systems even though public sewer service is available.

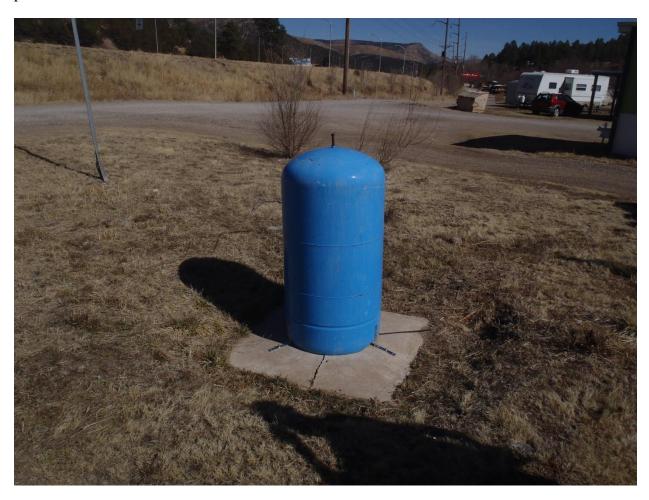
The Cherokee Well is located in a residential area along the lower reach of Cherokee Bill Canyon. Although the area has public sewer service, it is possible that onsite wastewater systems may exist in the region. The Village plans to install a fence around the well to restrict public access to the wellhead.

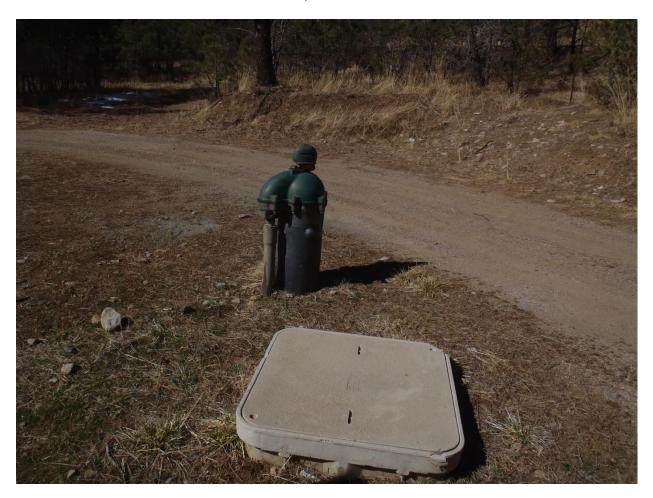
The Green Well (replacement) was drilled in 2007 to replace the original Green Well. It is located in Eagle Creek Canyon in a forested area with no known manmade potential sources of contamination. The road to Ski Apache and several unpaved roads, where petroleum products could be released in a motor vehicle accident, are in the area.

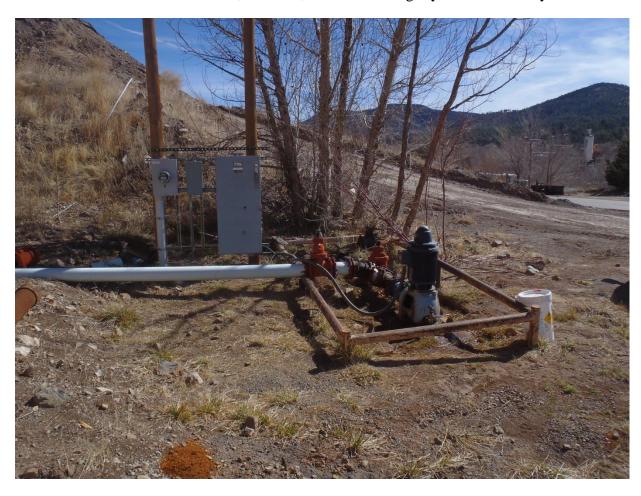
The existing Hollywood Well was drilled in 1987 to replace the original Hollywood Well that was contaminated in 1985 with diesel from a leaky underground storage tank. The existing well is located in the lower part of Ruidoso with a number of underground storage tanks located within a one mile radius. The well, however, sits on a hill slightly above the valley bottom.
